#### CASE HISTORY

Consolidation of a failed slope between Prenestina New state highway and the Prenestina Old road, Fiuggi, Frosinone, Italy

PRODUCT	TENAX TT 400 and TENAX TT 300 SAMP geogrids
LOCATION	Fiuggi (FR), Italy
OWNER	Comune di Fiuggi
PROJECT	Dr. Ing. Pietro de Carolis
CONTRACTOR	Ondino Romeo - Napoli

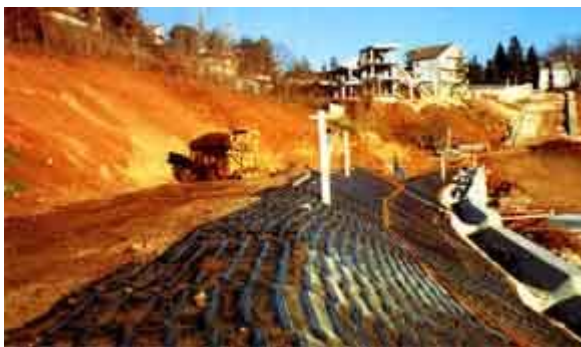
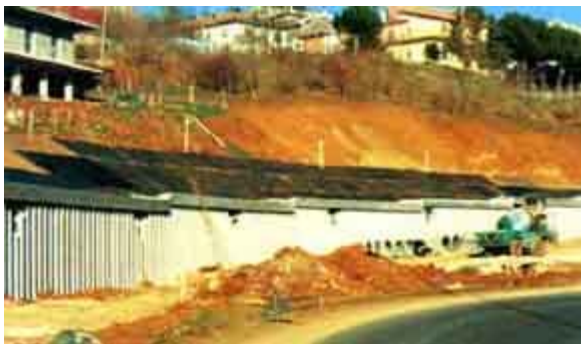
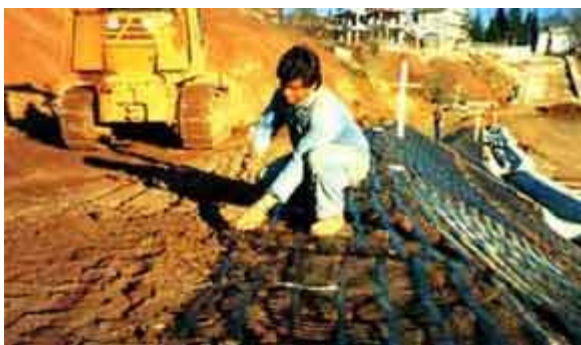
The installation of the geogrids was performed, in terms of the special demands of the project, using the "wrap-around" method: the geogrids were laid and fixed using "U" pegs; soil was then spread and compacted; the geogrids were then turned over and re-fixed.

The landslide was consolidated using the reinforced soil technique. The fallen soil (which consisted of silt of pyroclastic origin and reworked clay of colluvial origin) was replaced with other materials with better mechanical characteristics which were available on site (volcanic pozzolan).

This was then reinforced with TENAX TT 400 SAMP and TENAX TT 300 SAMP geogrids.

The job was extremely simple and was performed by unskilled labour using normal soil moving equipment. The job was completed with the addition of non structural concrete panels (used for their attractive appearance) along the service road, which was located half way down the slope, and at the foot of the slope. The problem of drainage was solved by putting coarse gravel between the reinforced soil wall and the concrete panels, thus creating a drainage channel.
